LARRY BEARD HOME INSPECTIONS

Inspection Report

Property Address:
2200 Fictitious Lane
Goodtown MS 39208

General Summary

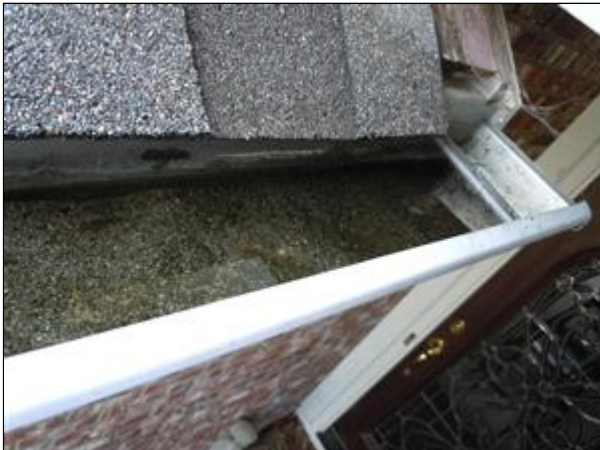
1.3 Picture 1

The gutter is holding water due to incorrect slope towards downspout at the front (left of main entry). Gutters that drain poorly or clogged can lead to many costly problems such as deterioration of fascia, soffit or roof edge. It can also cause gutters to pull loose and lead to possible water intrusion. The decking above the gutter has deteriorated due to water backing up from the gutter. A qualified person should repair or replace as needed.

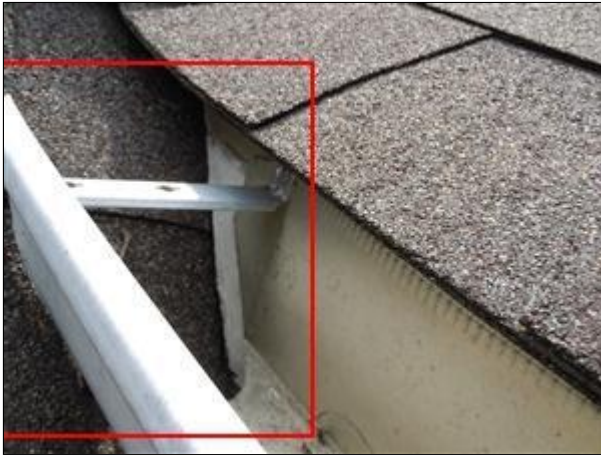
2.0 Picture 1

The Wood trim at the left side (facing front) is not flashed at the end of the short gutter across front. Deterioration can eventually occur if not corrected. A qualified person should repair or replace as needed.

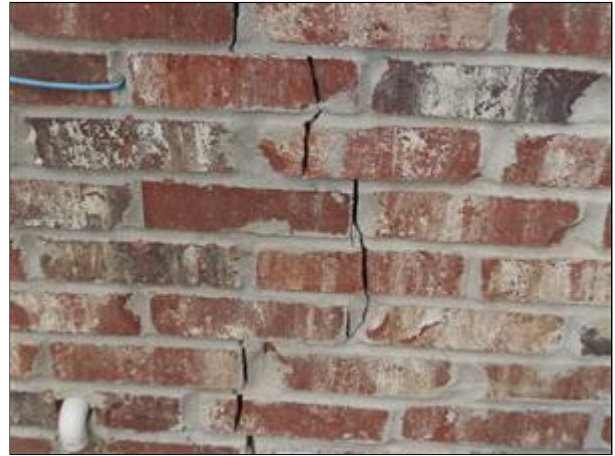
2.0 Picture 2

The Brick siding at the left side (facing front) has a crack at the mid-point of the wall. This is common with homes built on the clay subsoil in this area. I recommend monitor and repair as desired. If the crack widens to more than 1/4 inch I recommend an inspection by a qualified structural engineer.

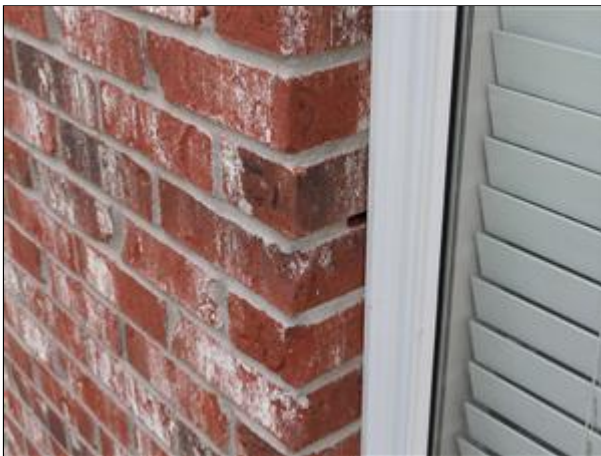
2.1 Picture 1

The sill and window facing is missing some of the mortar at left side (facing front) and right side (facing front). Deterioration may occur if not corrected. A qualified contractor should inspect and repair as needed.

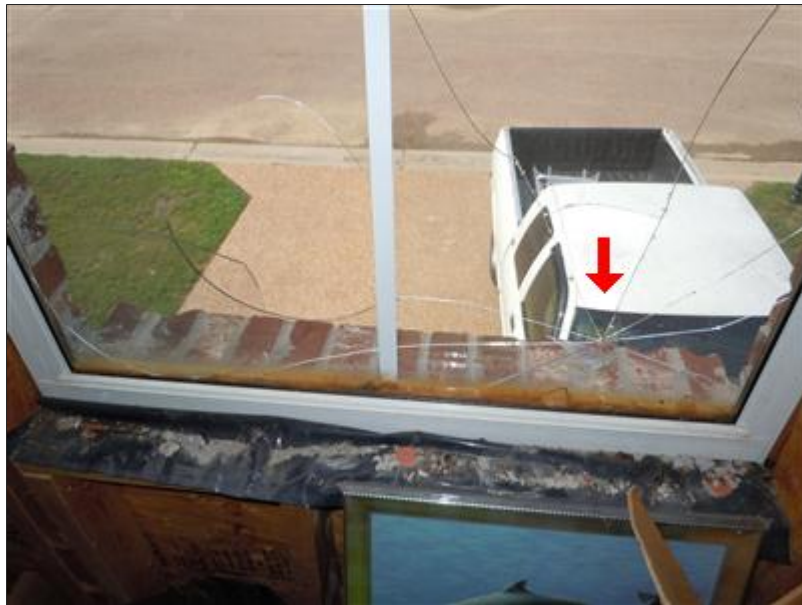
2.1 Picture 4

The window has broken glass on the exterior pane of the insulated sash at front of home above the garage. The interior pane is still intact. This is a maintenance issue and is for your information. I recommend repair as desired.

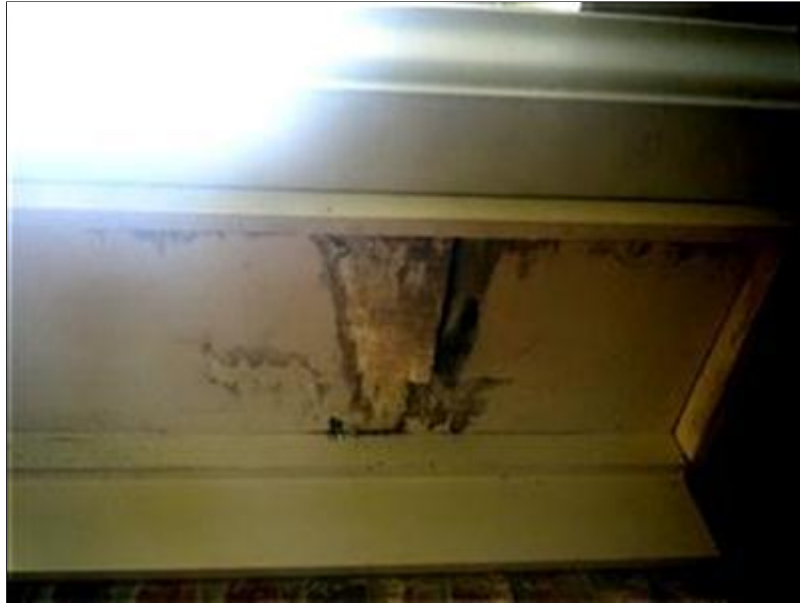
2.4 Picture 1

The soffit panel at eave on the left side (facing front) is deteriorated. Further deterioration may occur if not repaired. A qualified contractor should inspect and repair as needed.

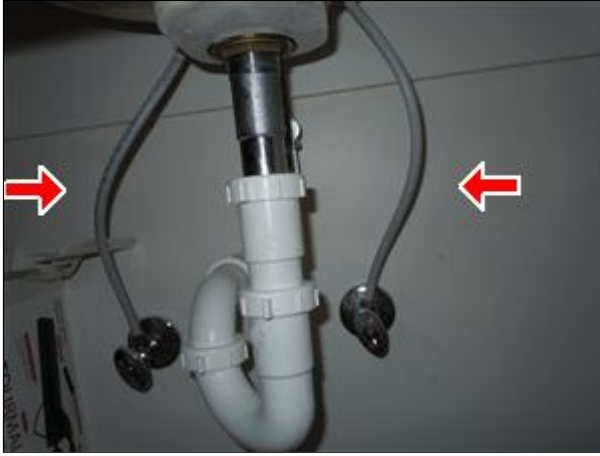
6.1 Picture 1

The water supply line is polybutylene, which has less life expectancy than some other materials at the master bath and hall bath. This is not considered up to today's standard. No apparent problems were found.

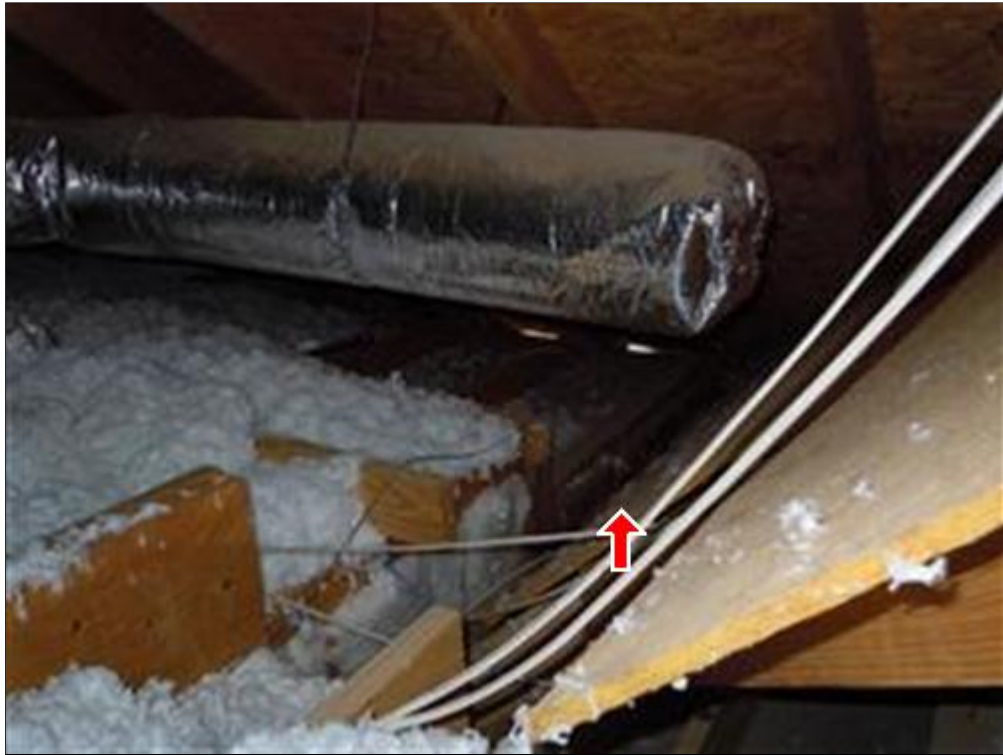
9.0 Picture 1

The attic insulation is blown in and is at the top of the rafters in most places but is not completed above the front bedroom.
